**SHIRE OF SERPENTINE AND JARRAHDALE**

**PRELIMINARY & DETAILED SITE INVESTIGATION  
\*EXECUTIVE SUMMARY\***

**Waste Transfer and Recycling Facility  
40 Watkins Road, Mundijong  
Western Australia 6123**

**MAY 2024  
DRAFT (REV1)**

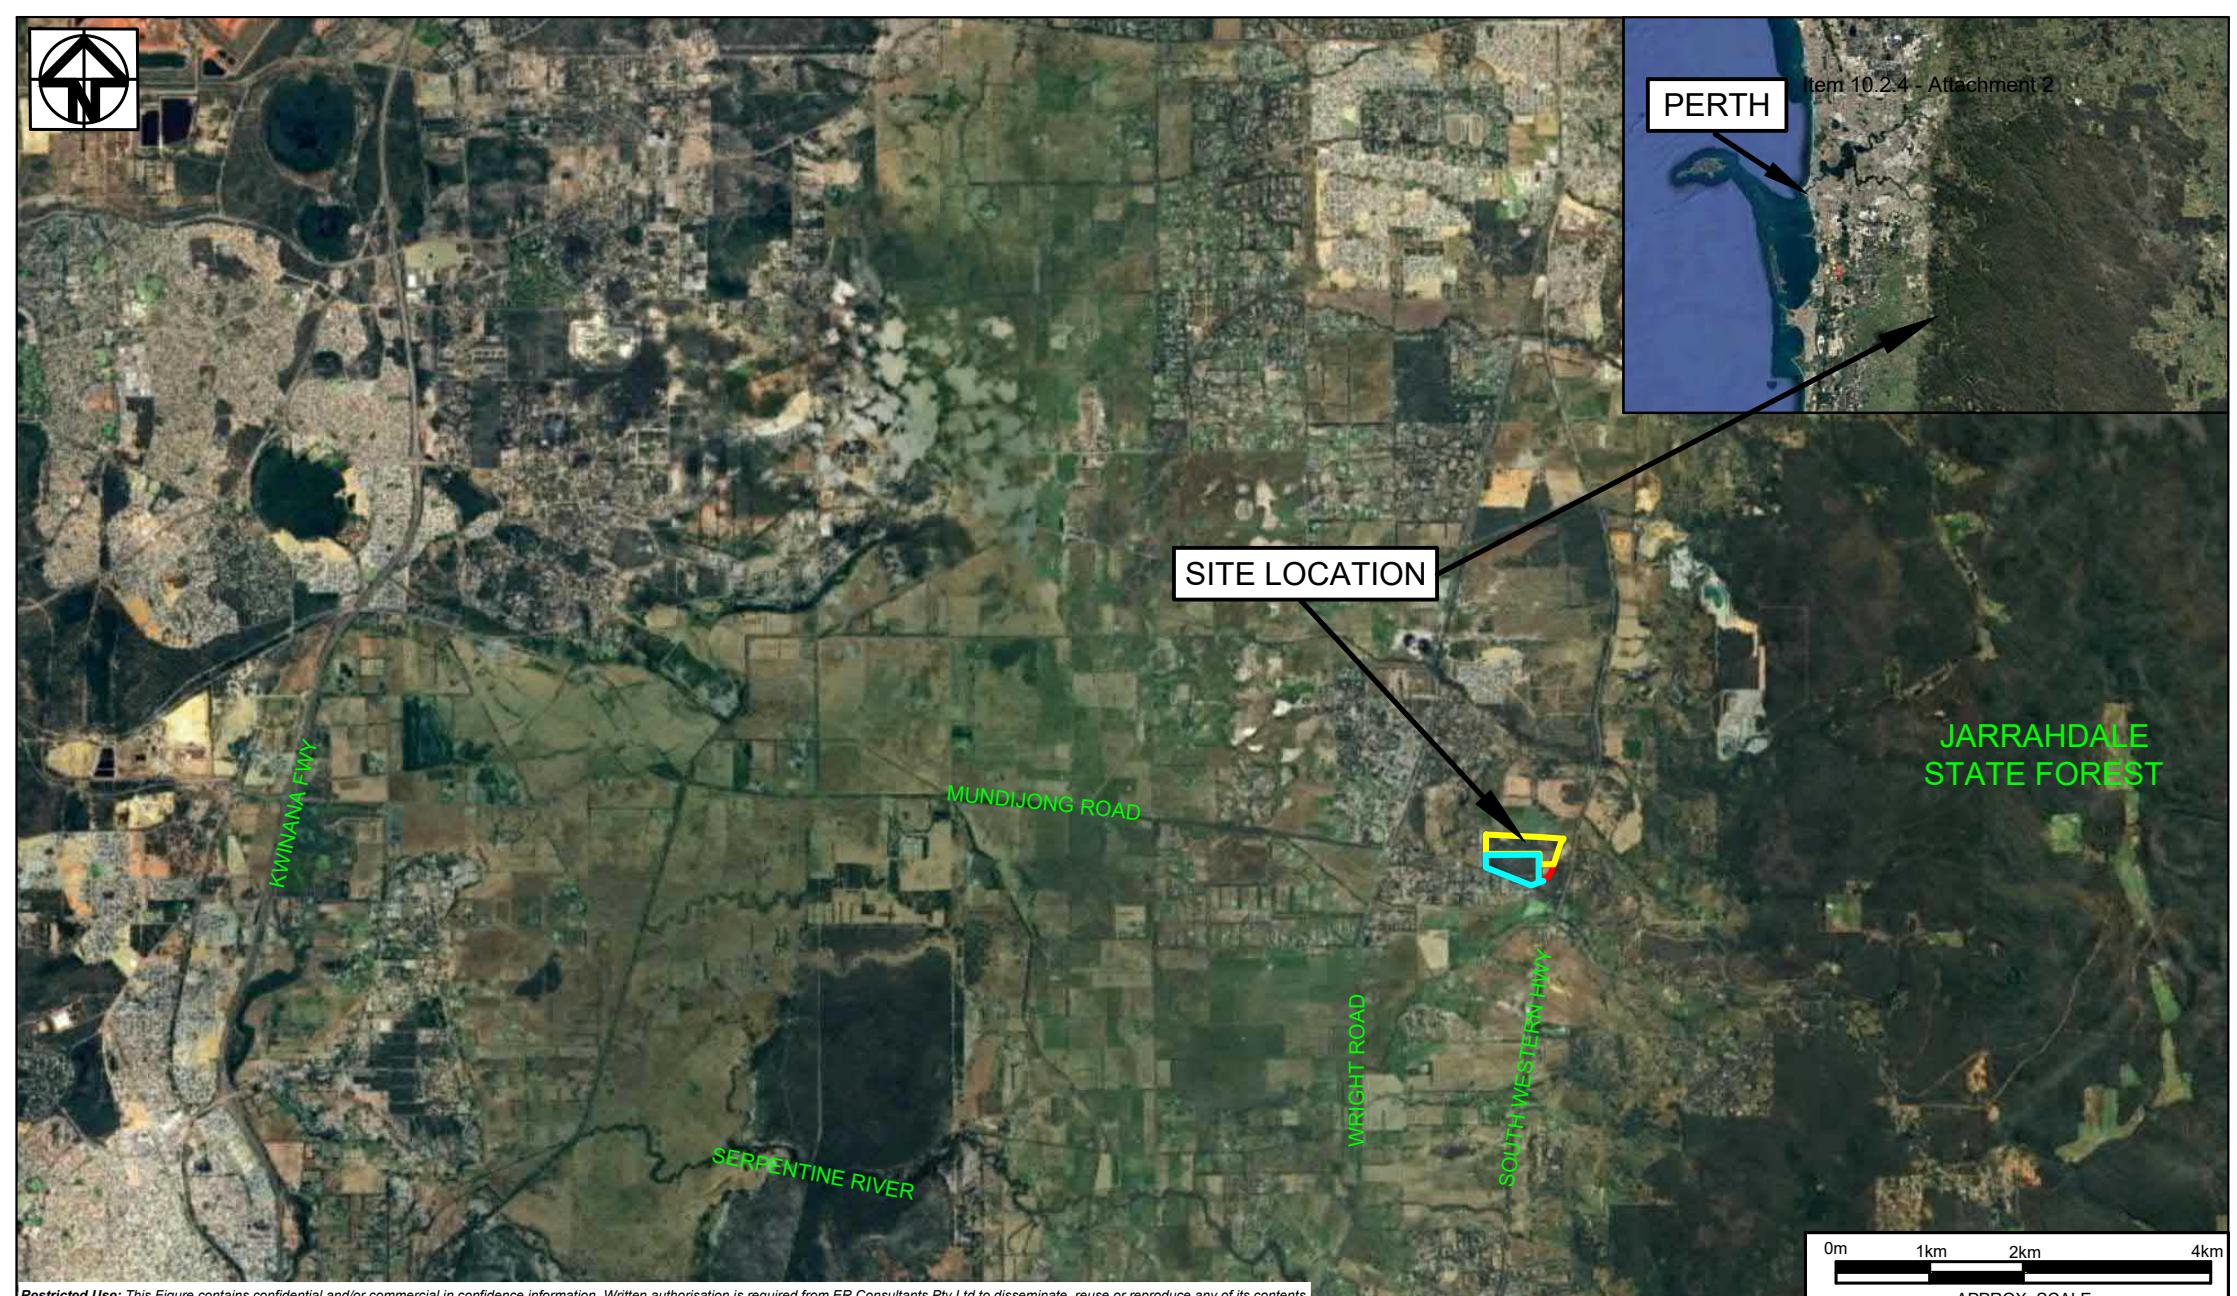
ER Consultants Pty Ltd (ERC) was engaged by shire of Serpentine Jarrahdale (the Shire), to undertake a detailed site investigation (DSI), to investigate and assess the contamination status of the Watkins Road Transfer Station (WTS), located at 40 Watkins Road, Mundijong, WA 6123 (Figure 1).

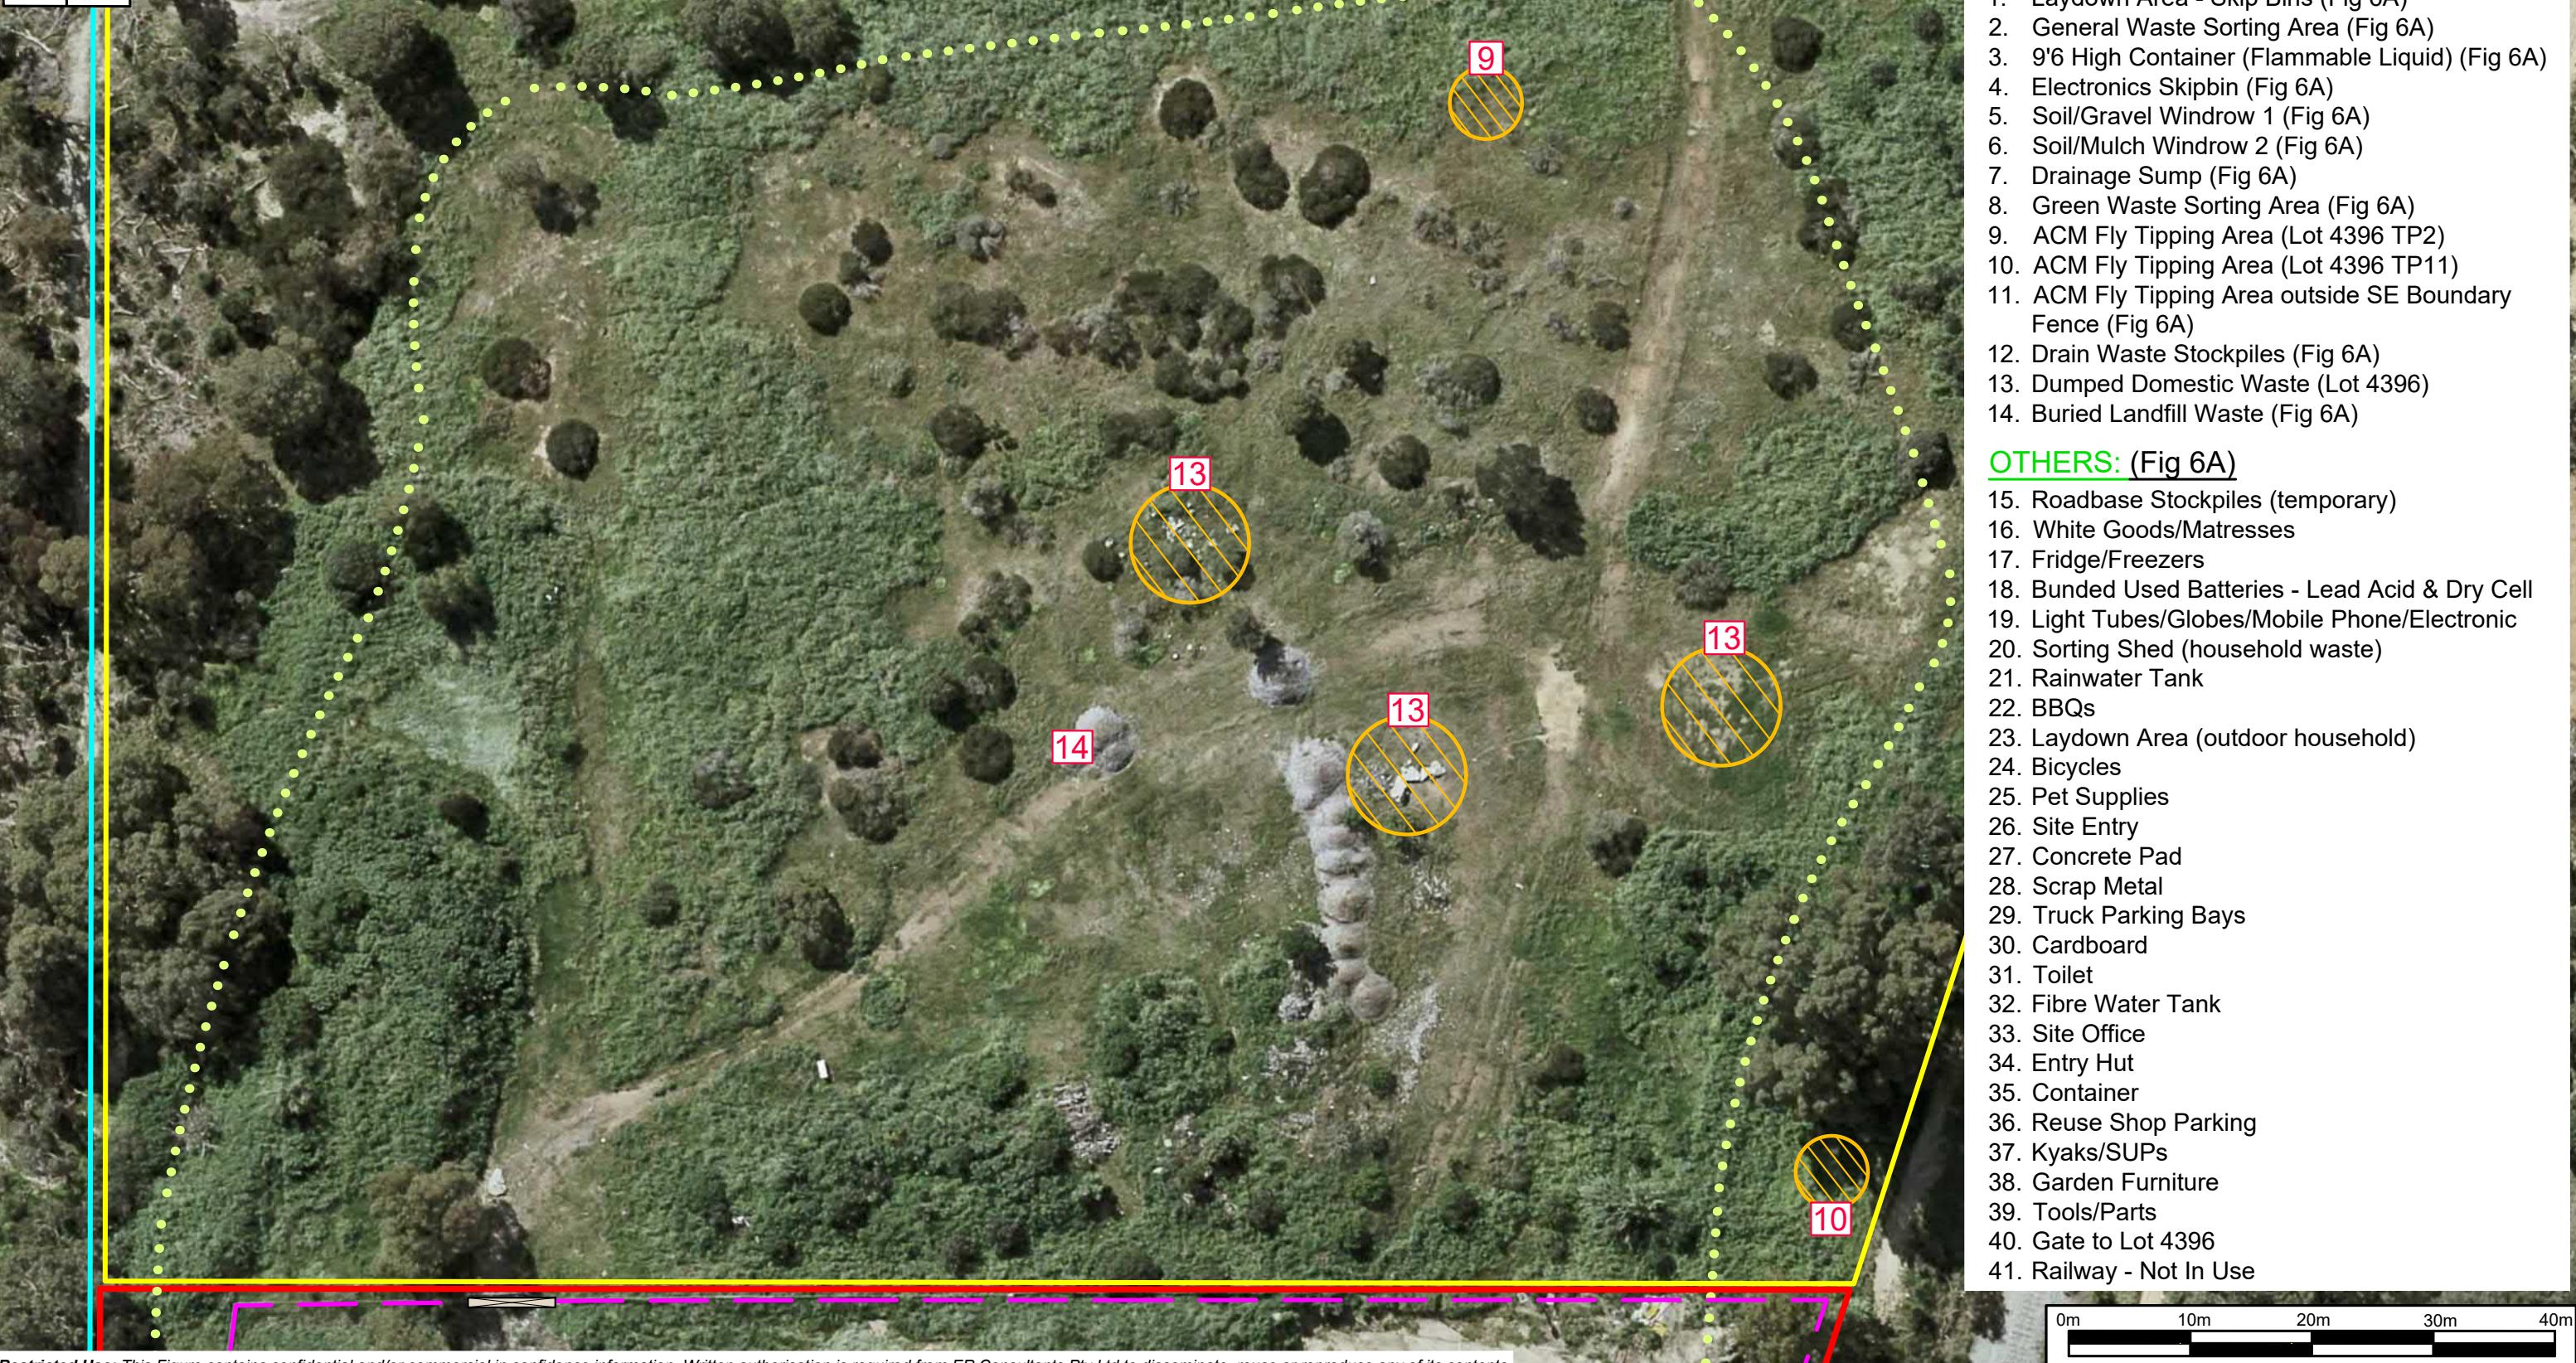
## FIGURE 6B

Figure 6B displays the locations of the features described below. It is noted that features with the potential to cause contamination are described as "Areas of Concern".

- The site is undulating and rises in elevation in a general easterly direction. The observed undulations are attributable to the buried waste material beneath the site.

- Numerous areas of illegally dumped surface waste were observed, including household goods, sand/gravel, building material and ACM.
- The fencing surrounding the site was observed to be in a condition unable of preventing unauthorised access and illegal dumping. As such, the problem is likely to continue unless the area can be adequately fenced off.

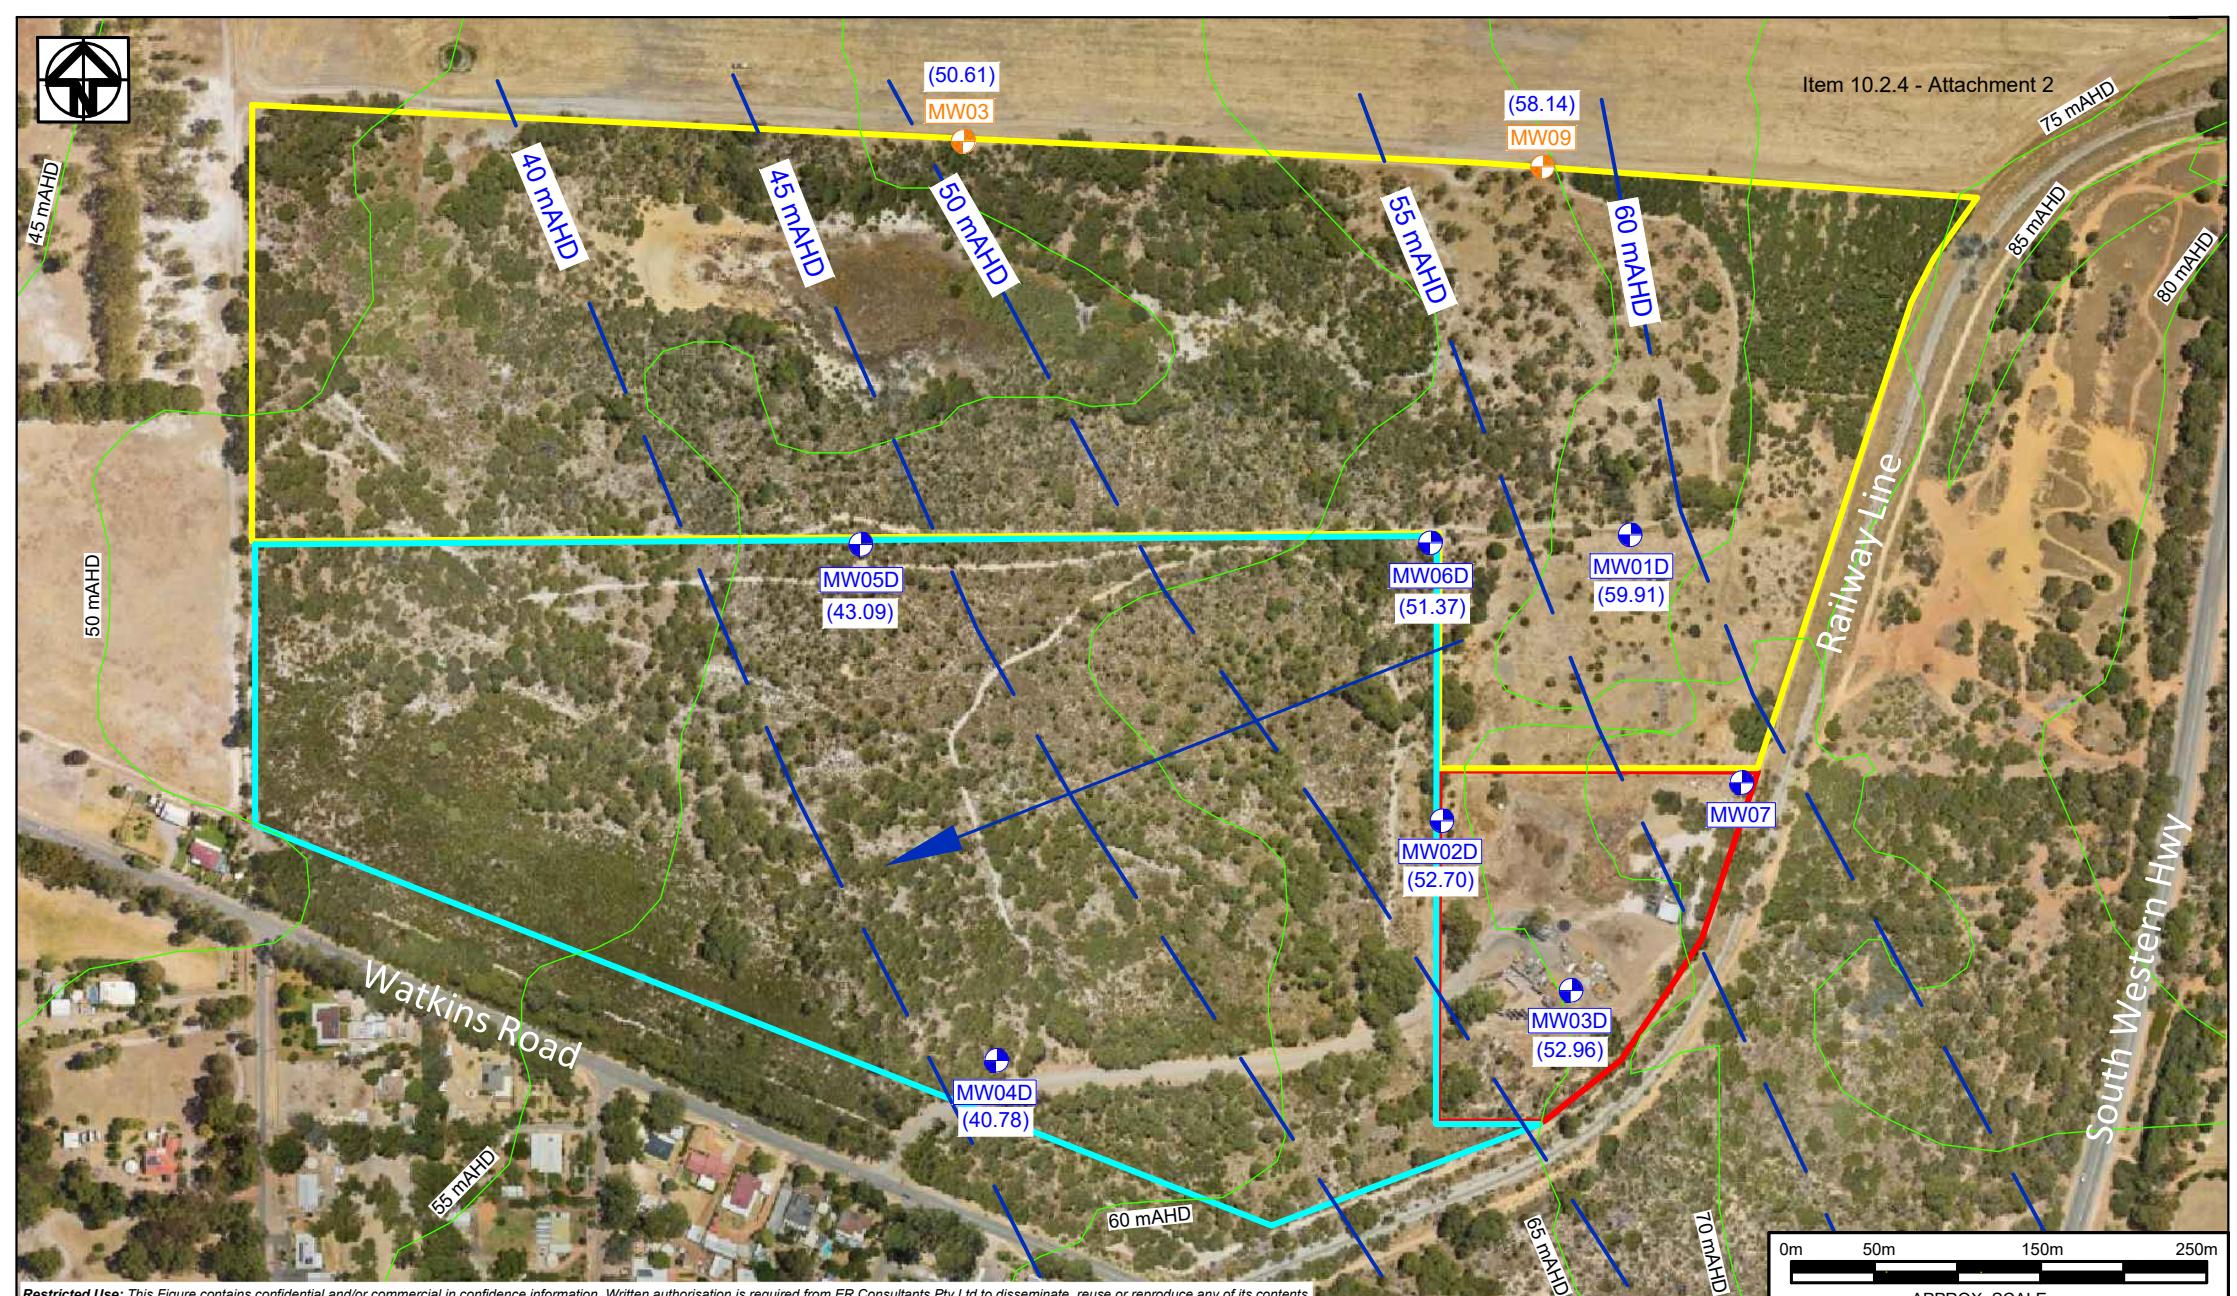
- Figures 6a & 6b present the areas of concern (AOC) identified as part of the project.
- Figures 7 to 9 present the sample locations.
- Figure 10 presents the inferred groundwater flow direction.

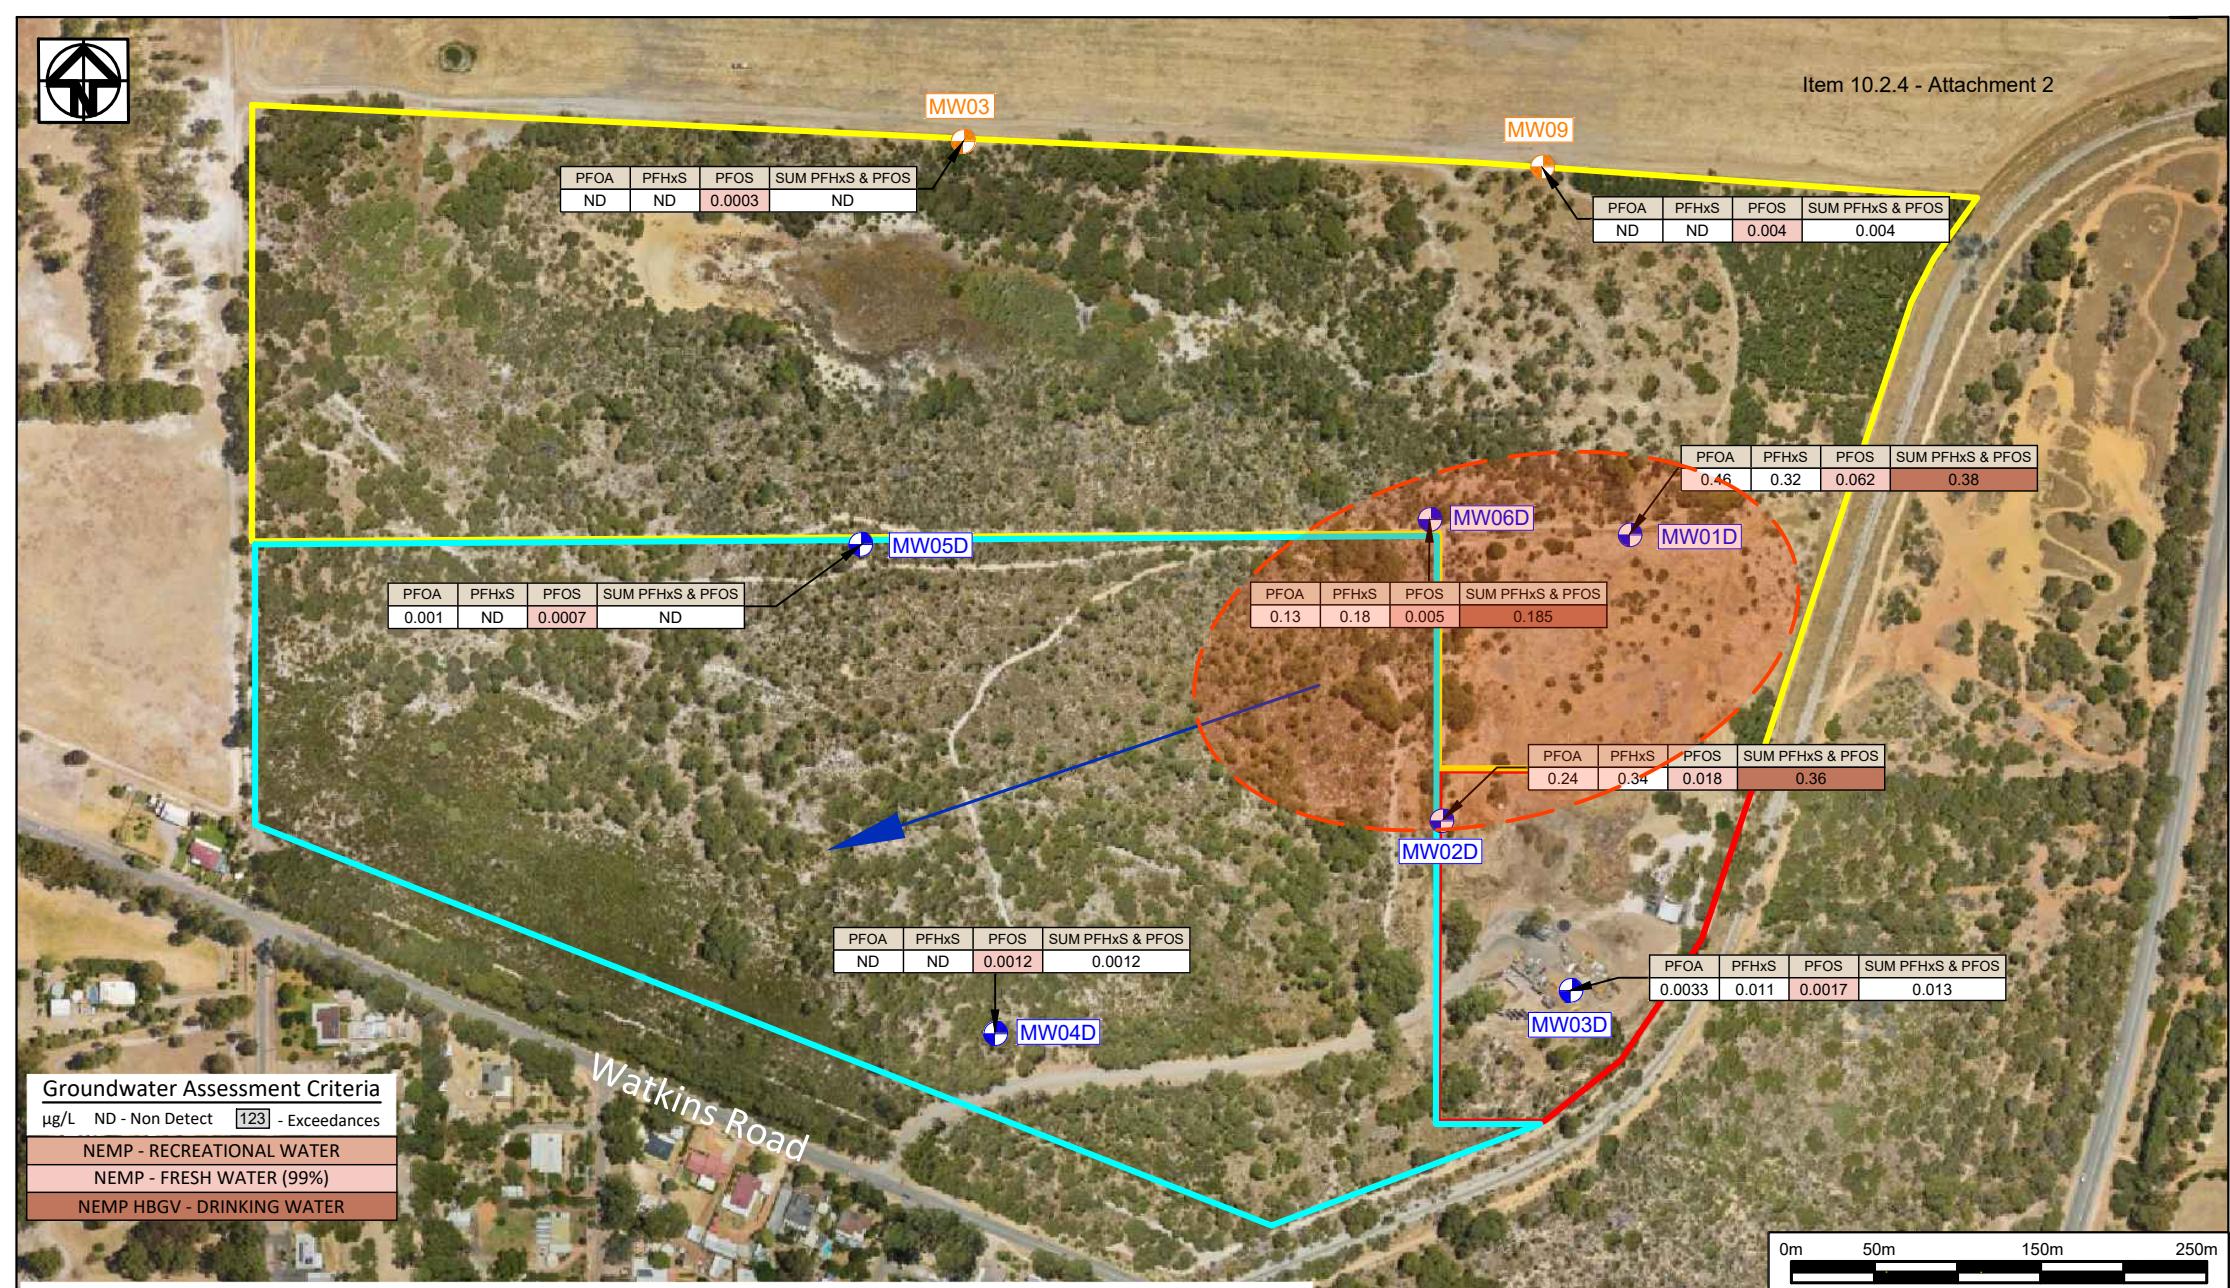
**FIGURE 12B**

- PFAS groundwater contamination (sum PFHxS & PFOS) was identified in MW01D (DBCA land), MW06D (DBCA land) and MW02D (WTS) at concentrations that may represent a potential human health risk if ingestion were to occur. It is noted that this assessment is based on the adoption of the drinking water guideline which is a conservative approach. The contaminant "plume" can be inferred to extend to the southwest along a similar path to the DPH and may extend marginally beyond the boundary of the WTS at concentrations exceeding the drinking water screening levels (Figure 12B).

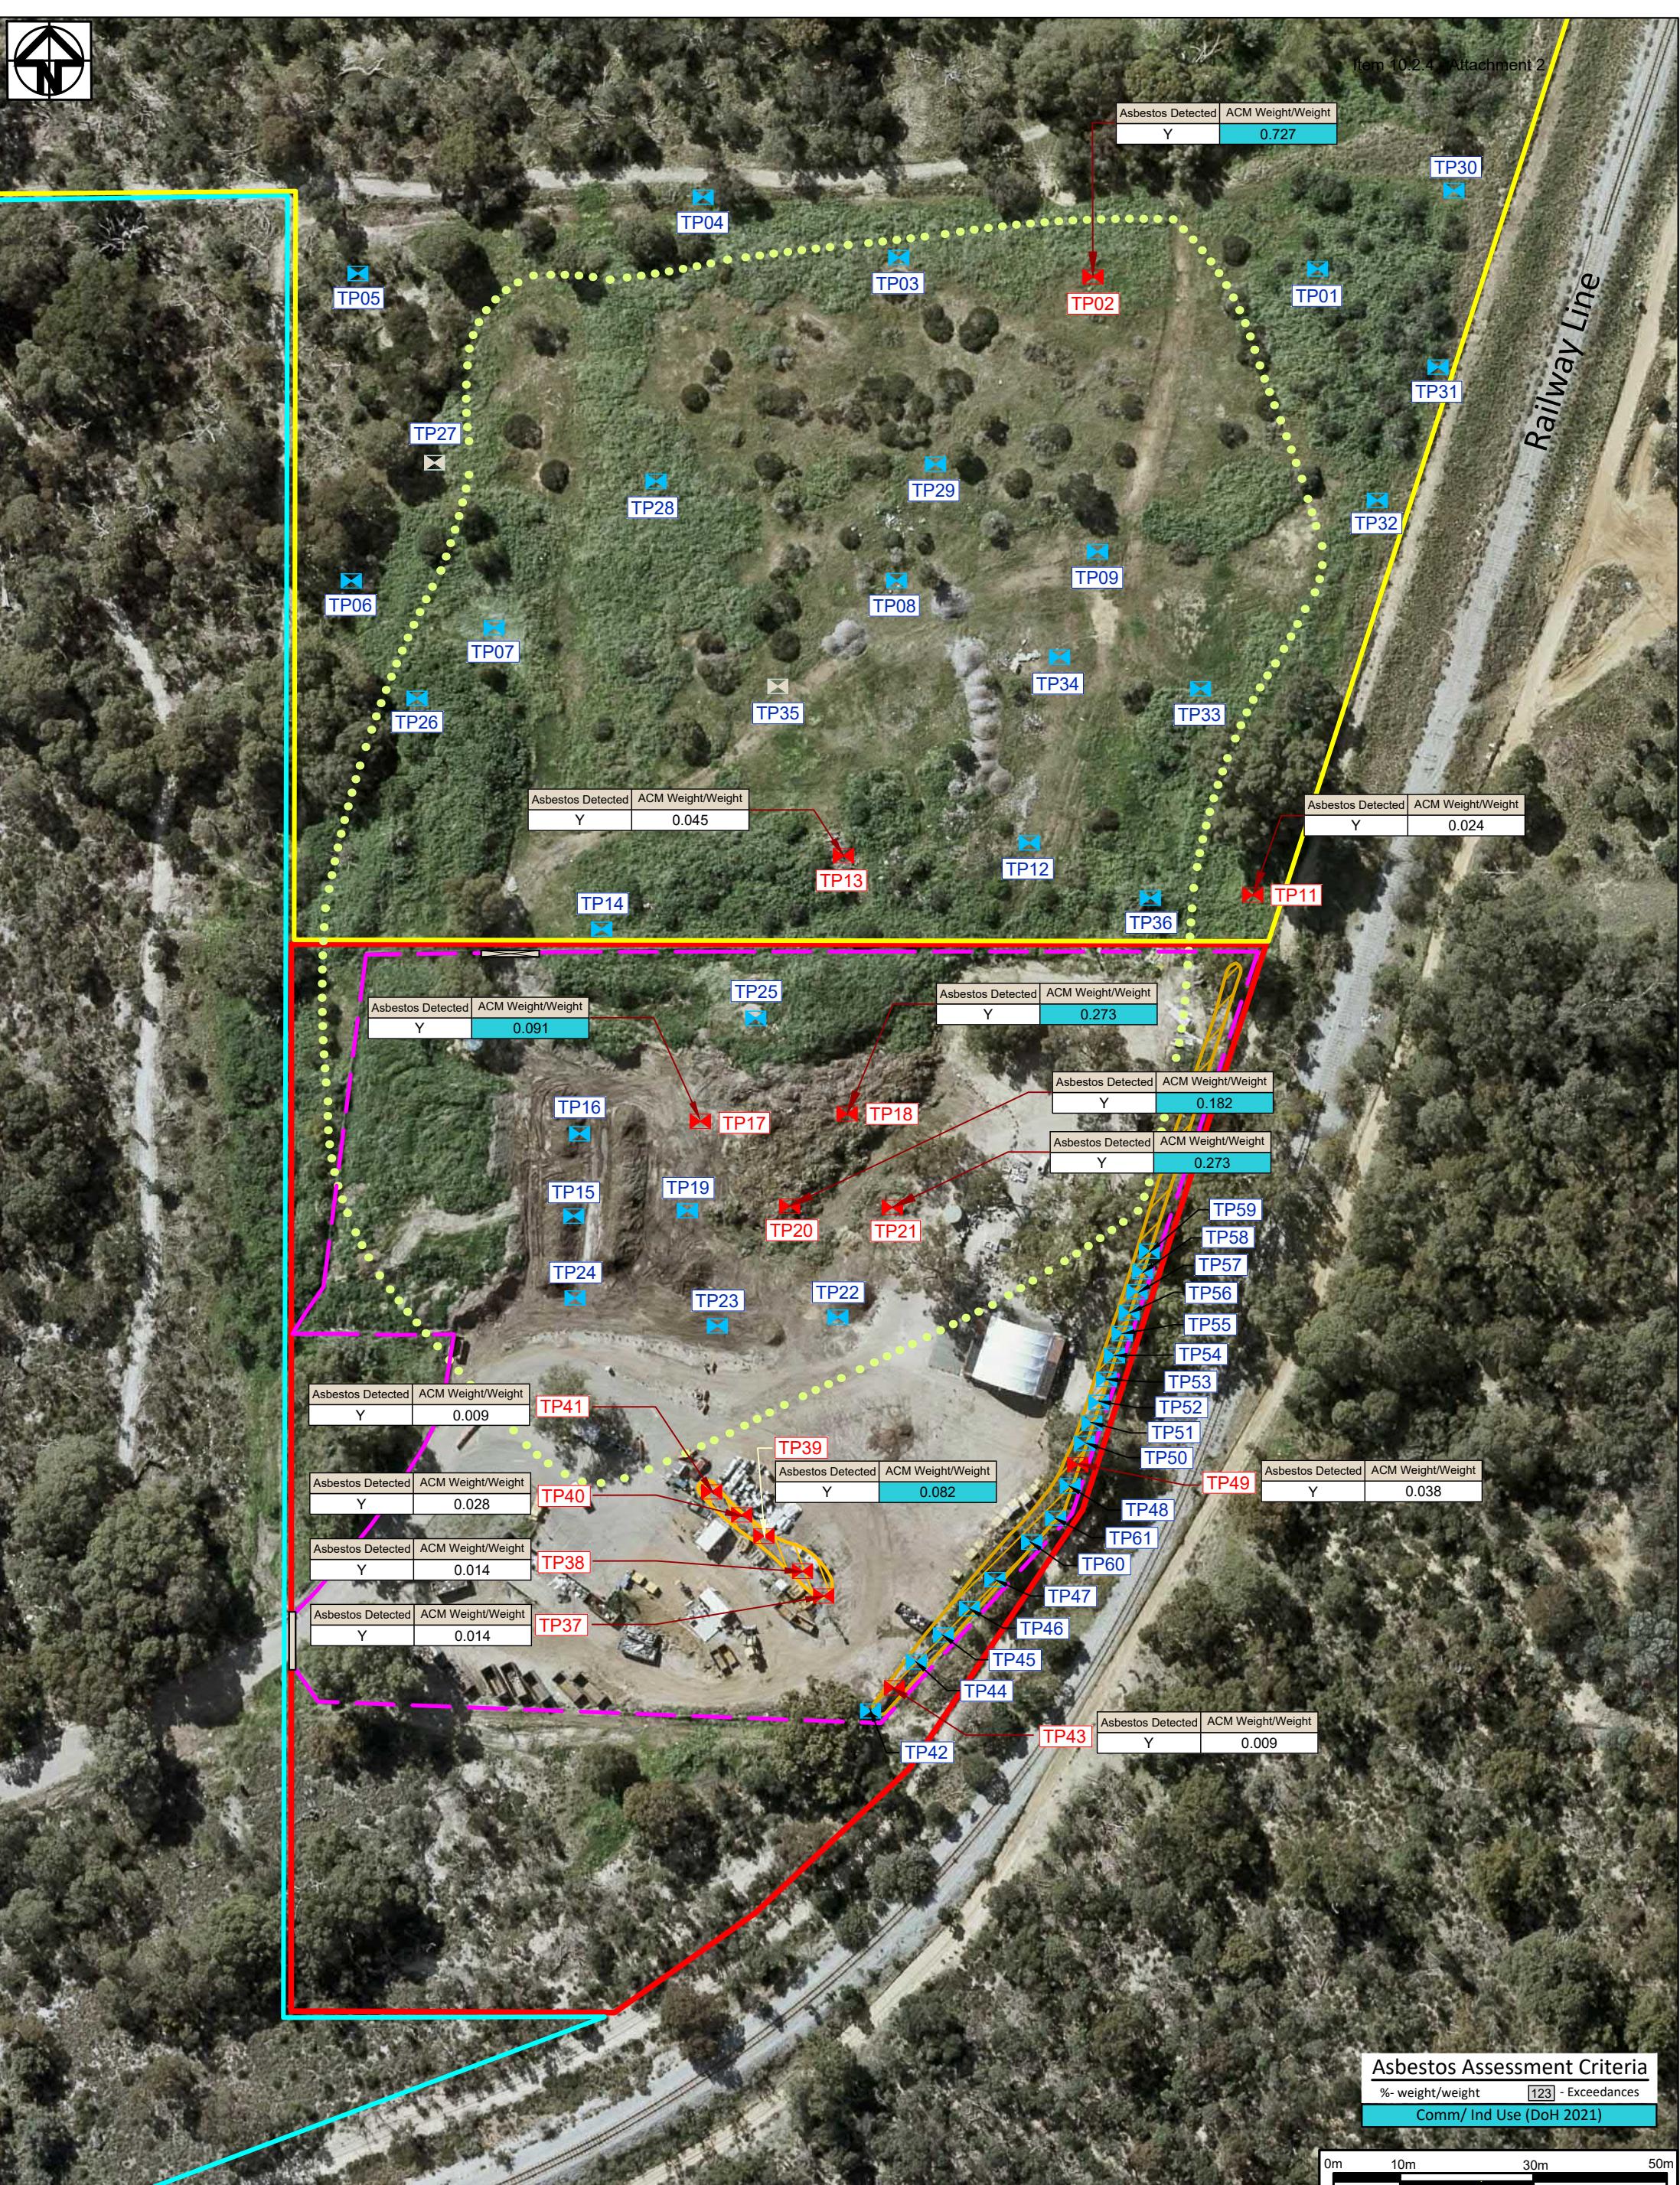
FIGURE 13

- Figure 13 identifies the locations where gravimetric ACM was detected in shallow soils at concentrations with the potential to pose a risk to human health.

- Two windrows comprising cut material from the site (Windrow 1) and green waste mixed with sand (Windrow 2) were observed. Windrow 1 is contaminated with ACM debris throughout, whereas Windrow 2 reported isolated ACM impact from north to south (see Figure 13).

- Although ACM impact was identified in Windrow 2 (WTS), (Figure 13) it is present at concentrations below the screening criteria for industrial sites and as such represents a low risk. However, it is recommended that management of this material be included with the overall asbestos management strategy for the site.

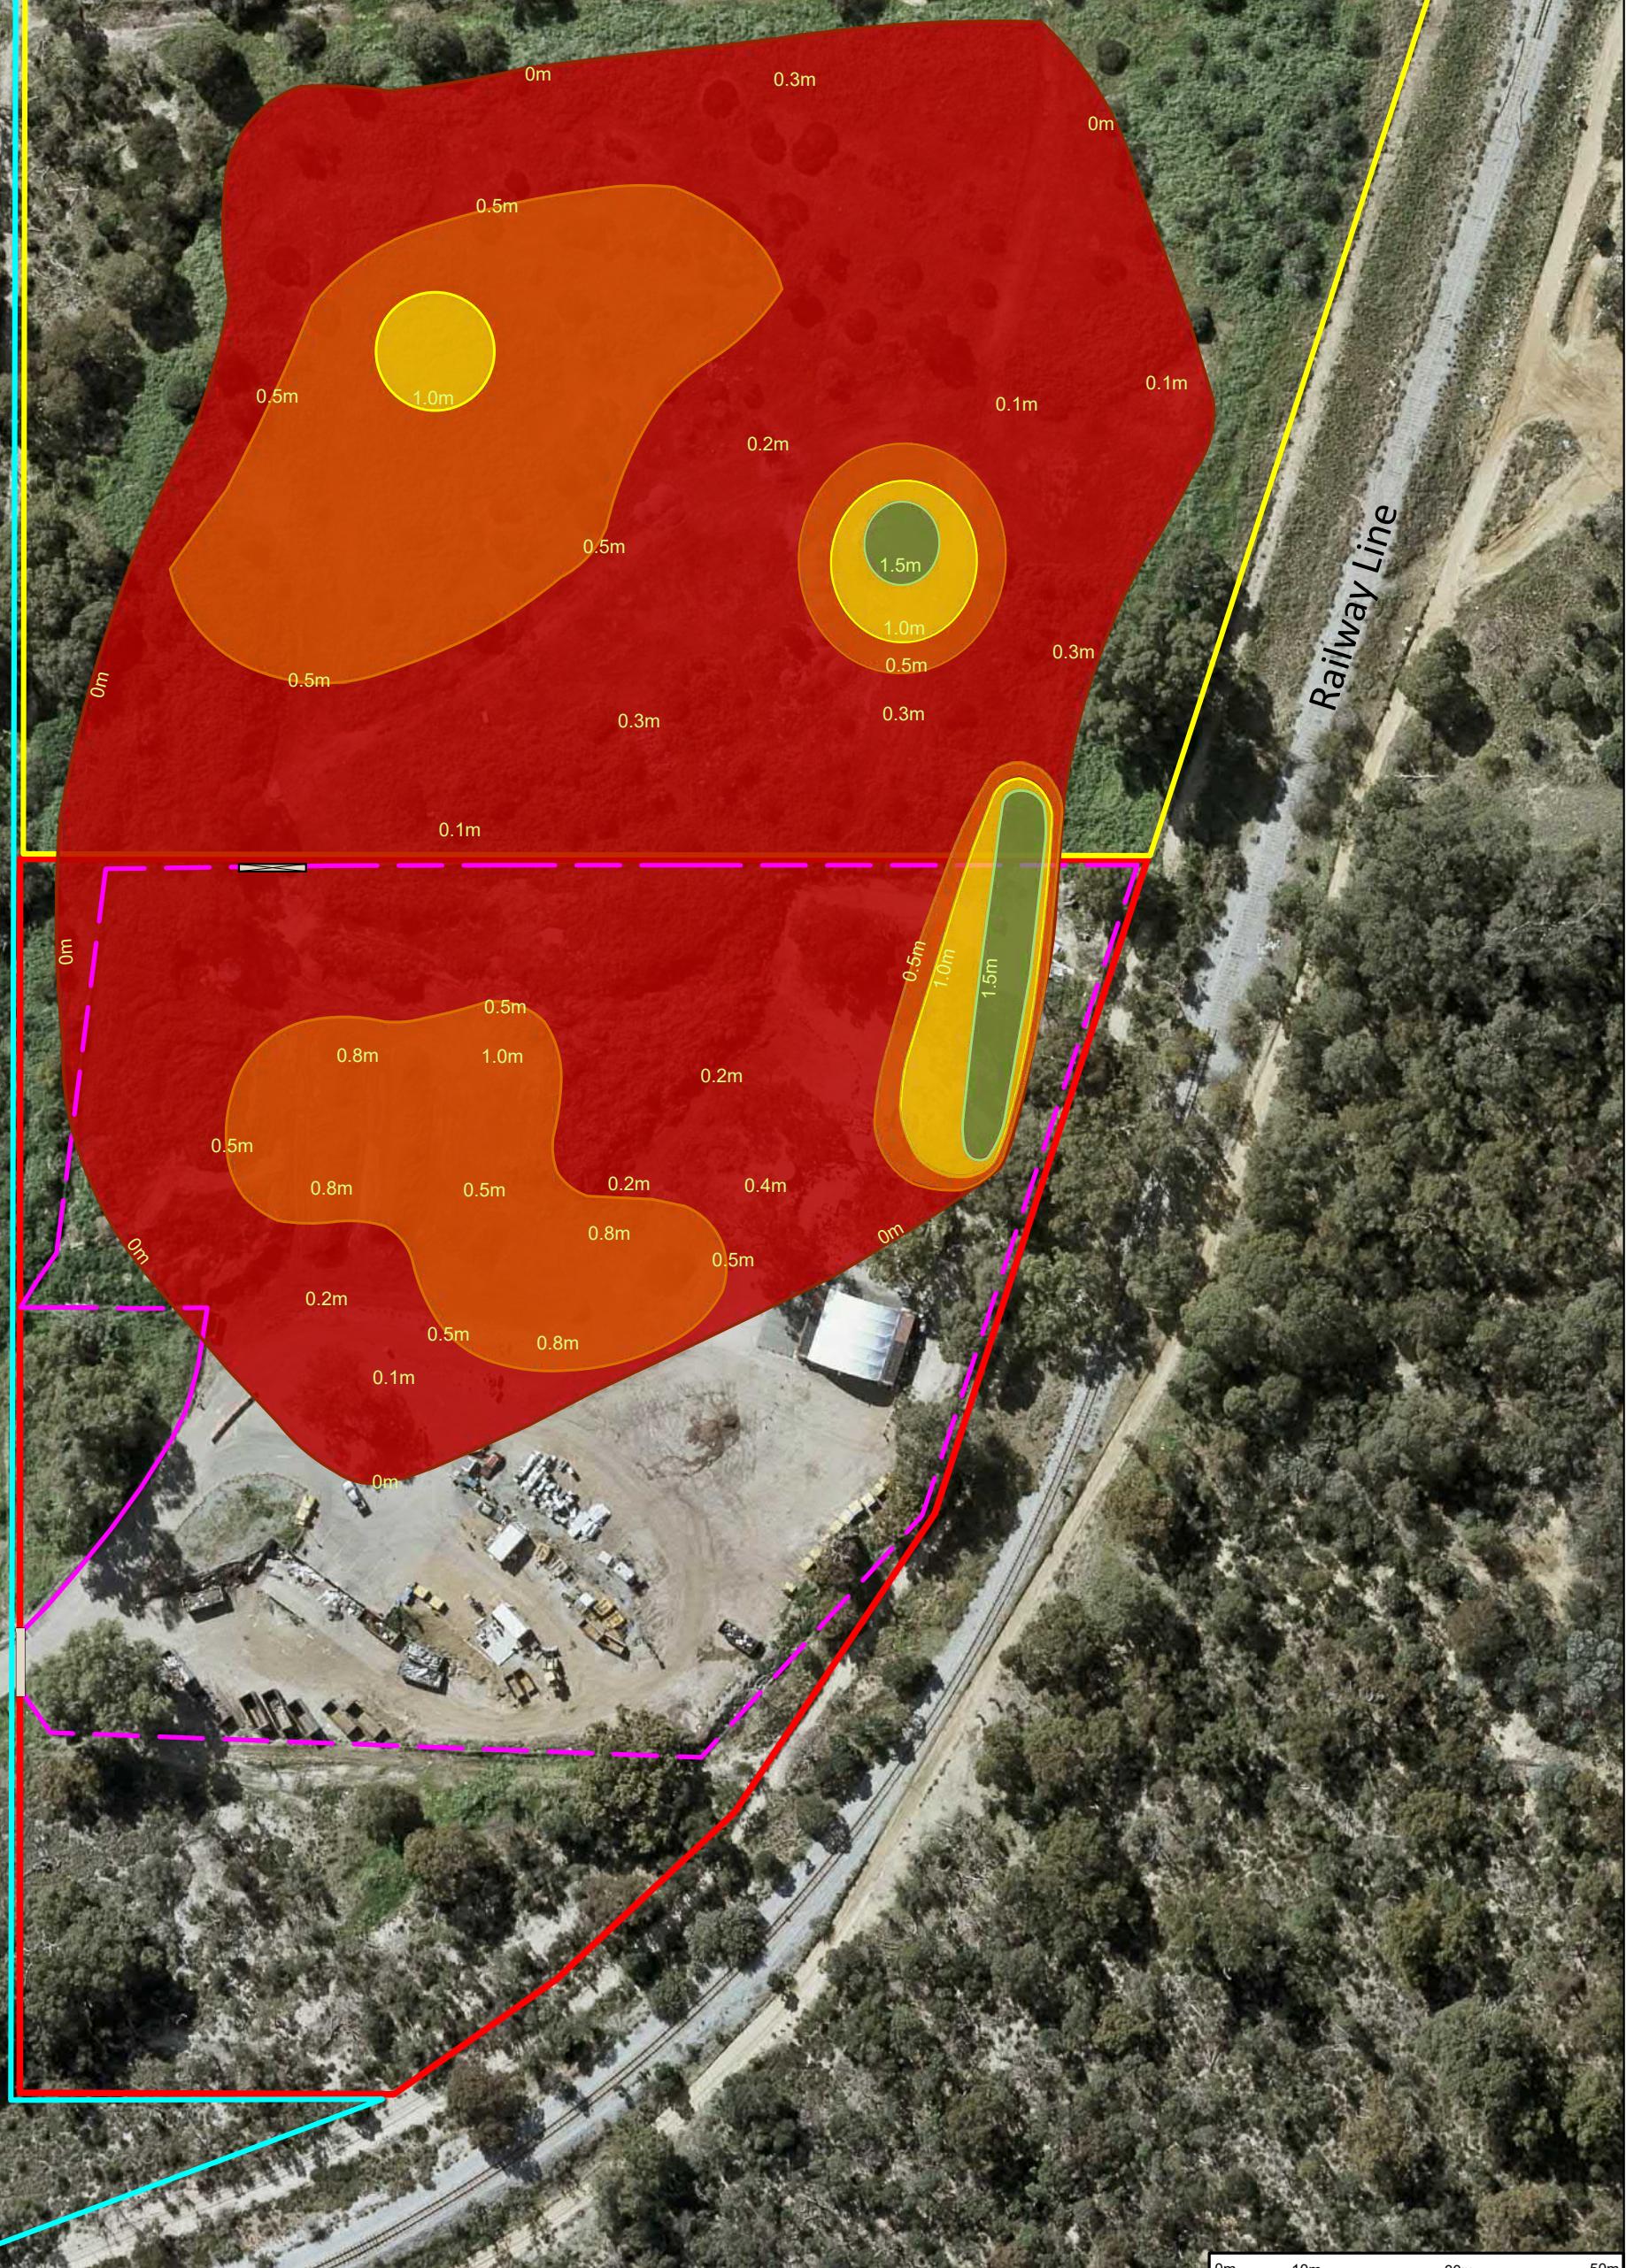
- Figure 14 presents a visual representation of the inferred landfill cap thickness across the site, based on test pit and soil bore observations on site.

- During test pitting works, a landfill cap was observed above the buried waste, with thickness generally between 0.2m and 1m across the area (see Figure 14). ACM contamination was identified within the landfill cap material close to the site surface at four test pit locations (see Figure 13). This may indicate that ACM impacted material was inadvertently used to cap the landfill areas over 20 years ago, or smaller quantities of ACM debris brought to site over the site's operational history, may have penetrated the site surface through vehicular action, predominantly occurring in the green waste processing area.

- During test pitting works, a landfill cap was observed above the buried waste, with thickness generally between 0.2m and 1m across the area (see Figure 14). ACM contamination and/or impact was identified within the landfill cap material close to the site surface at three test pit locations (see Figure 13). This may indicate that ACM impacted material was inadvertently used to cap the landfill areas over 20 years ago, or smaller quantities of "fly-tipped" ACM debris may have penetrated the site surface through vehicular action (which appears to have occurred in the area).

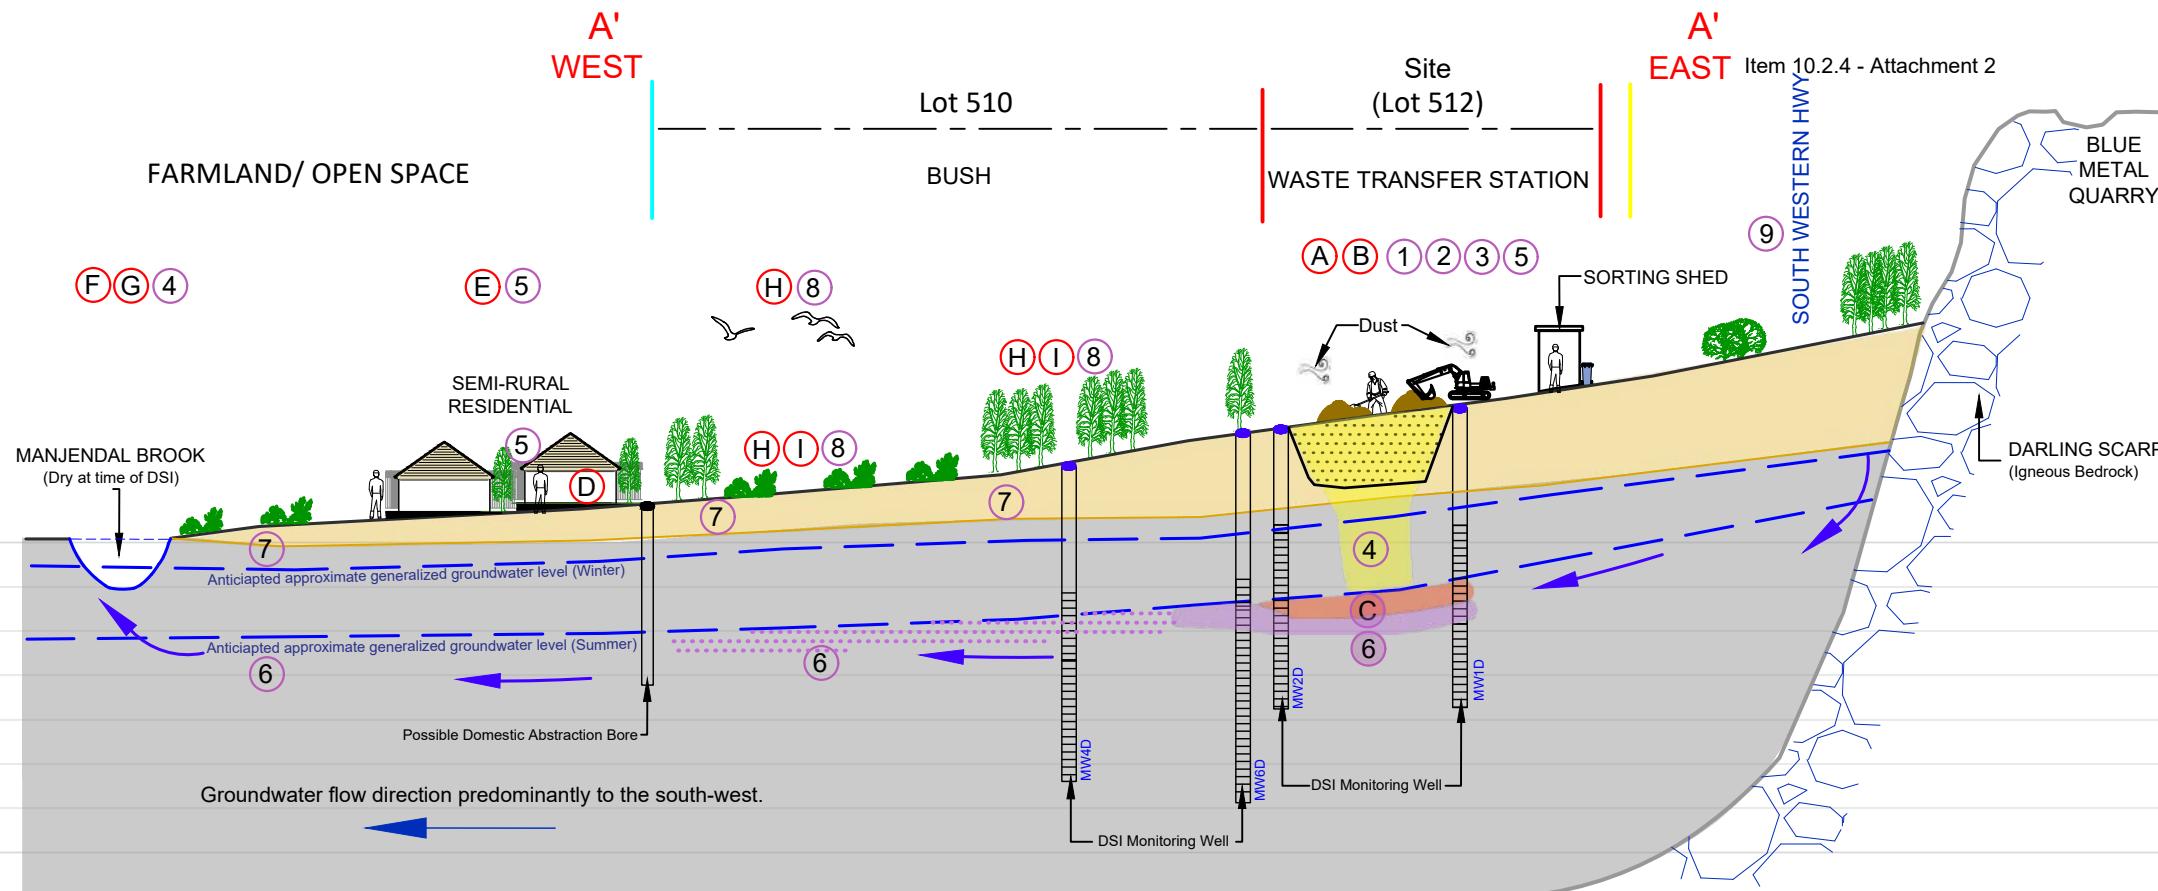
- Figure 15 presents the conceptual site model (CSM), which is a schematic conceptual view of how site contamination is linked to and may pose a risk to site users and/or surrounding human health and environmental receptors.

- Possible Linkage
- Linkage Complete
- SAND
- CLAY
- Historical Landfill (INERT & ACM)
- Inferred Extent of DPH Plume (> NPUG)
- Inferred Extent of Residue Soil Contamination
- Inferred Extent of PFAS Plume (> DWG)
- Inferred Extent of PFAS Impact (> FWG)
- Groundwater Movement
