# LOT 4 AND 5 KING ROAD, OLDBURY

## ENVIRONMENTAL MANAGEMENT PLAN

Prepared for: Aigle Royal  
Report Date: 31 July 2023  
Version: 2  
Report No. 2021-591

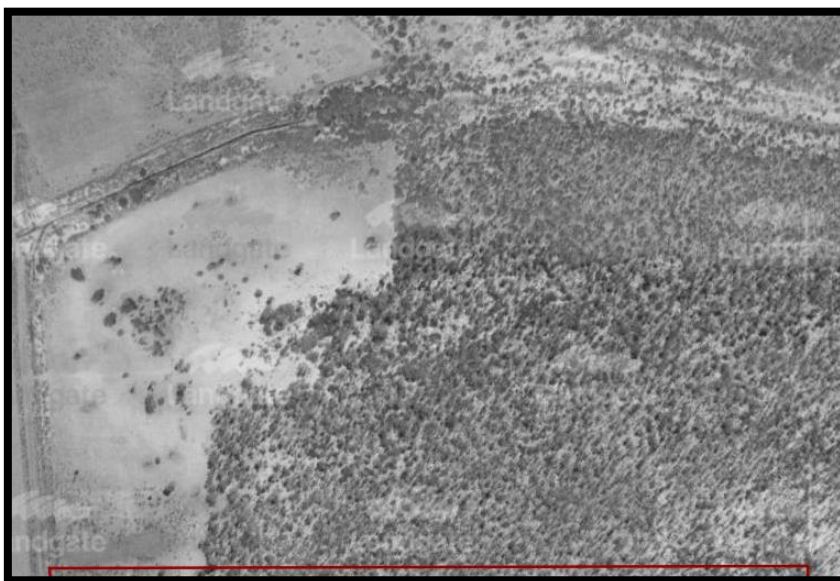
**Plate 1: Aerial Photograph 1953 (Landgate, 2021)**

The earliest available historic aerial photograph on-line from 1953 shows that the site is largely vegetated to the east and cleared in the west (Plate 1) (Landgate, 2021).

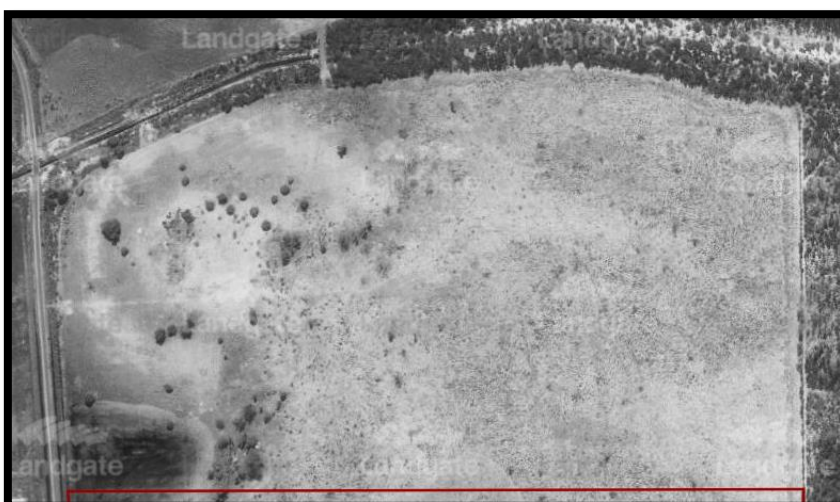
**Plate 2: Aerial Photograph 1974 (Landgate, 2021)**

The aerial photograph from 1974 shows the site has been extensively cleared (Plate 2) (Landgate, 2021). A wetland is apparent in the south-west corner of lot 4.

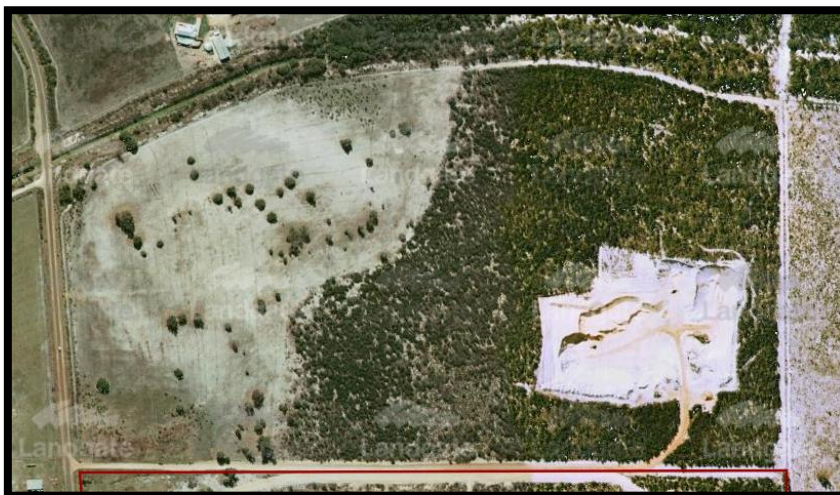
**Plate 3: Aerial Photograph 1985 (Landgate, 2021)**

The aerial photograph from 1985 shows the vegetation has regrown from the past clearing and sand mining has started in the south-eastern corner of the site (Plate 3).

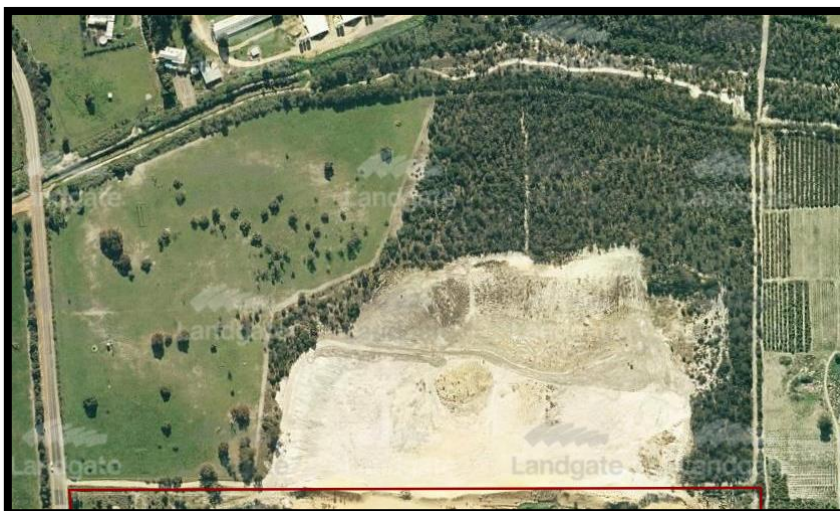
**Plate 4: Aerial Photograph 2008 (Landgate, 2021)**

Sand mining continued progressively over the next few years and the limit of the mining operation was reached in 2008 (Plate 4). The footprint of the mining operations extended into Lot 5 to the north of the site.

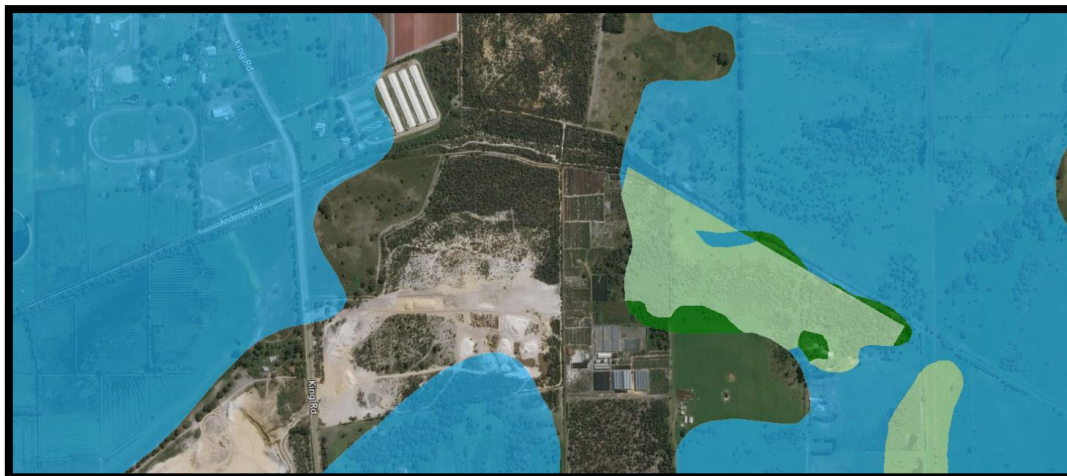
**Plate 6: Multiple Use Wetland Mapped on the Site**

The western part of the site contains a small area of a large Multiple Use Wetland (Unique Feature Identifier (UFI) 14704) that extends for 277ha over a wide area to the west and north-west of the site. The MU wetland is shown on Plate 6 as the blue area on the site. The wetland is classified as Dampland although the extent of the wetland indicates to PGV Environmental that it should more accurately be classified as a Palusplain wetland.

Resource Enhancement Palusplain, UFI 14860, is mapped approximately 175 m to the east as shown in light green on Plate 6. The Conservation Category Palusplain, UFI 7300, is shown in dark green on Plate 6 and is approximately 180 m to the east (National Map 2021).
